# **G3/G4 Facsimile Error Code List**

**REVISION 2**

**Canon**

**HY8-23A0-020**

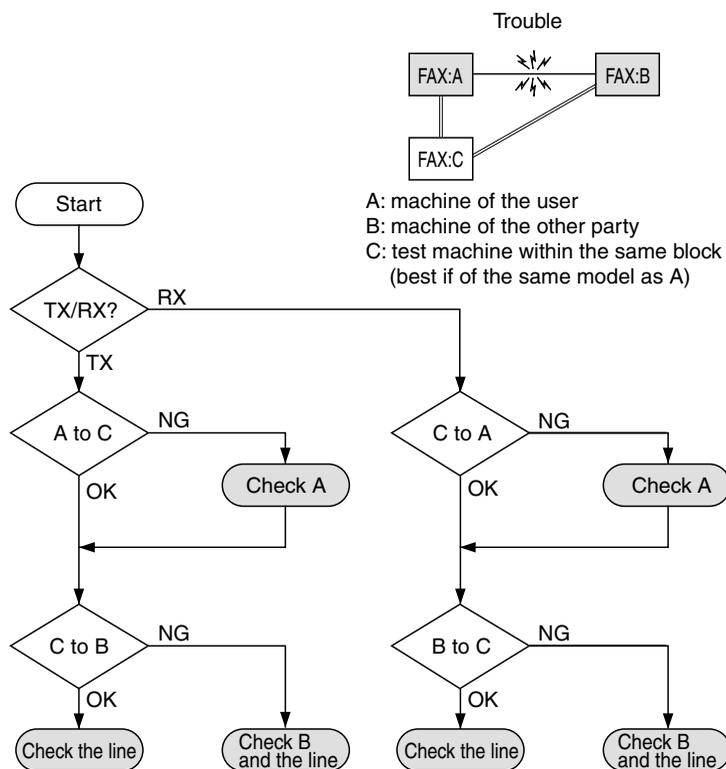
**Figure 1 3-Point Communication**

When a trouble occurs in communication, an error code will be indicated. At times, the cause of the trouble can readily be identified by means of an error code, while at other times it is difficult to find out whether the cause is in the transmitter, receiver, or telephone line.

A 3-point communication is used to find out the source of a specific trouble:

## 1.1 3-Point Communication

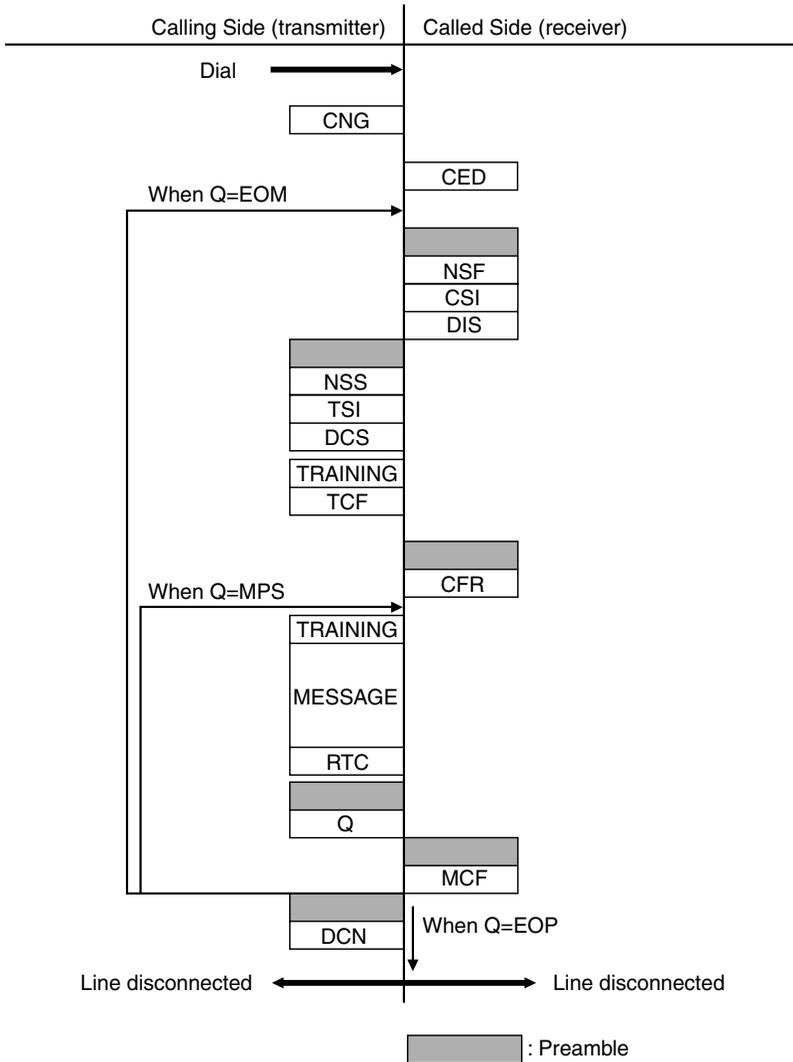
Figure 2 G3 Control Procedure

### 2.1 G3 Control Procedure

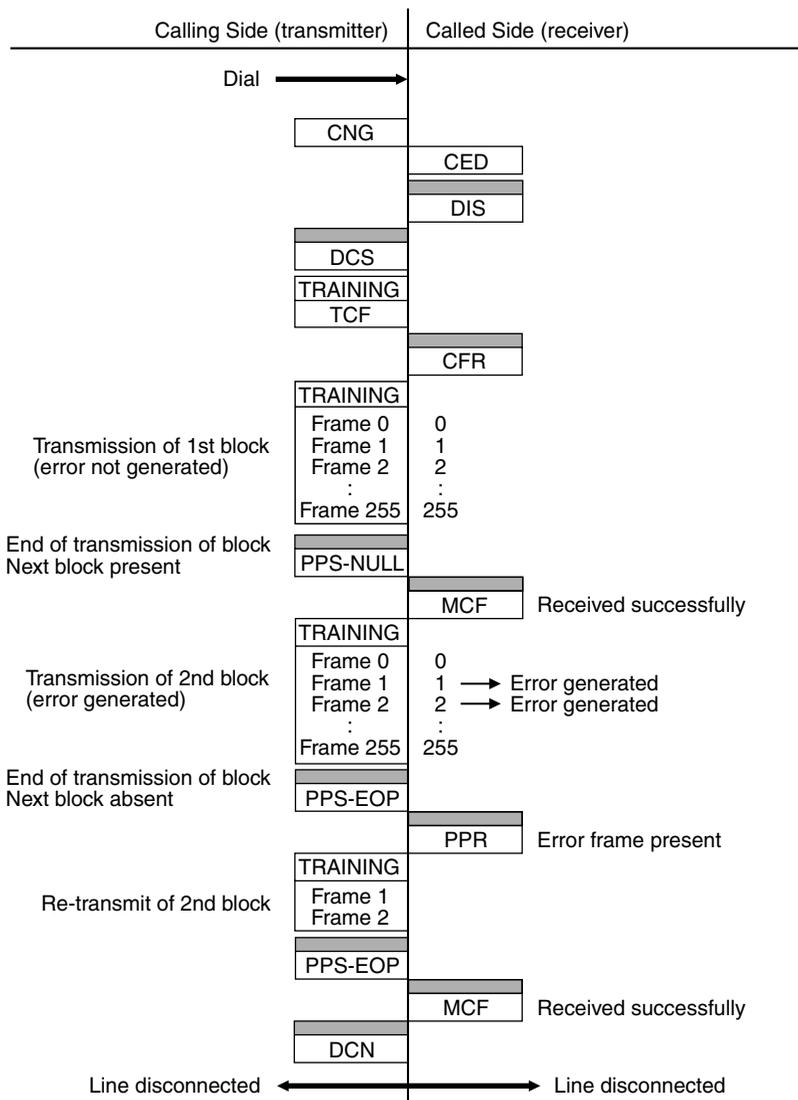
Figure 3 ECM Control Procedure

## 2.2 ECM Control Procedure

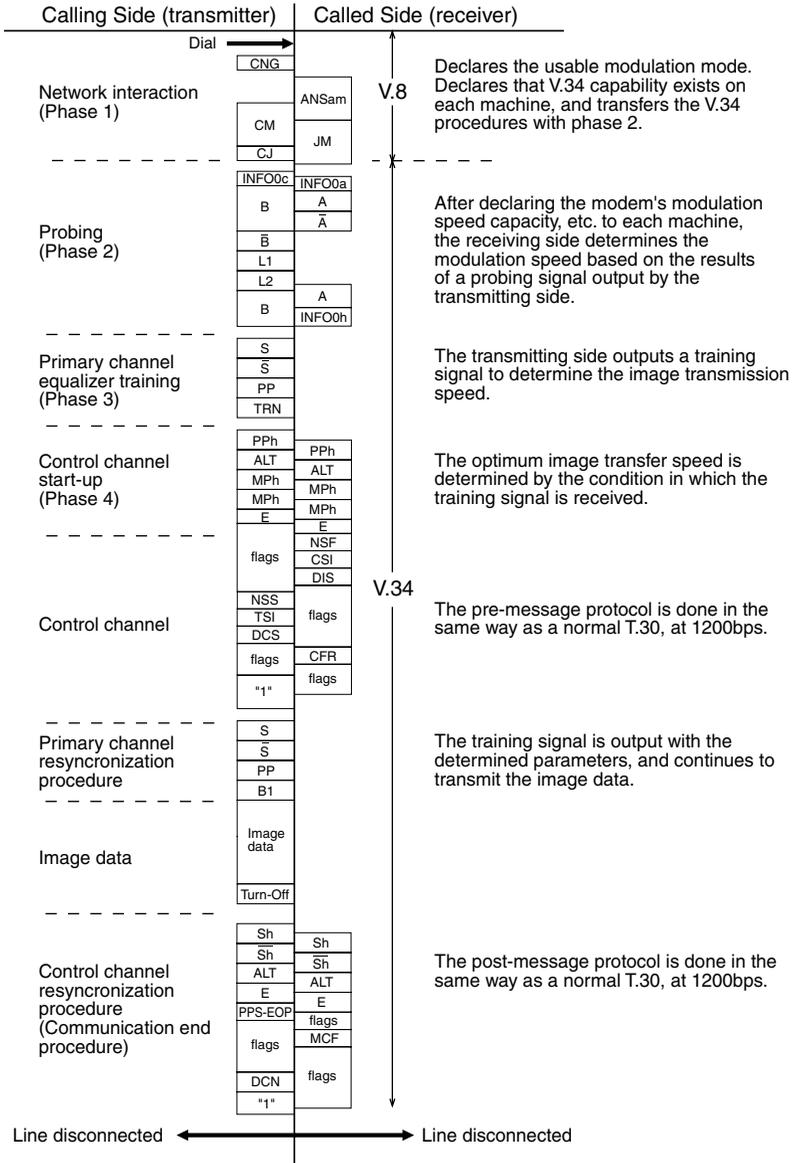
Figure 4 V.8/V.34 Control Procedure

### 2.3 V.8/V.34 Control Procedure

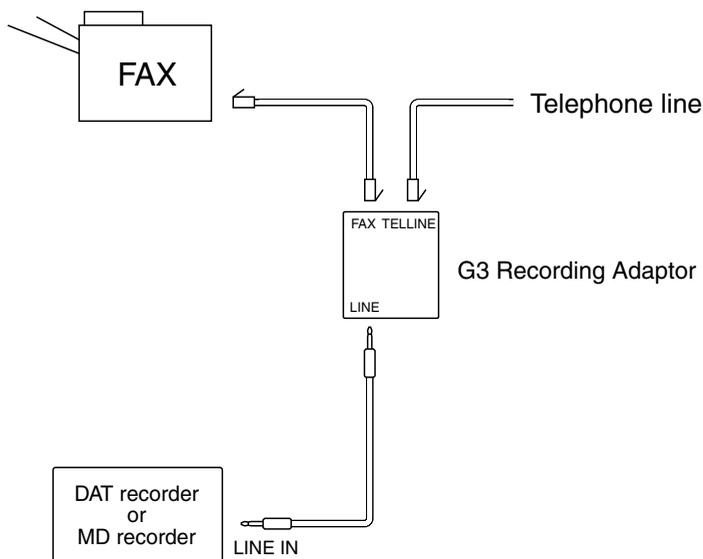
**Figure 5 Wiring Diagram for Recording the Protocol**

If a trouble cannot be corrected after troubleshooting according to the instructions in this manual and if the Remedy column reads "Record the protocol on a DAT or MD, and have it analyzed by the local Canon office and/or Technical Center." make a recording by referring to the following diagram:

Use Standard (SP) mode for recording.  
Set the recording level so that the sound of communication  
can clearly be heard with as little noise as possible when replayed.

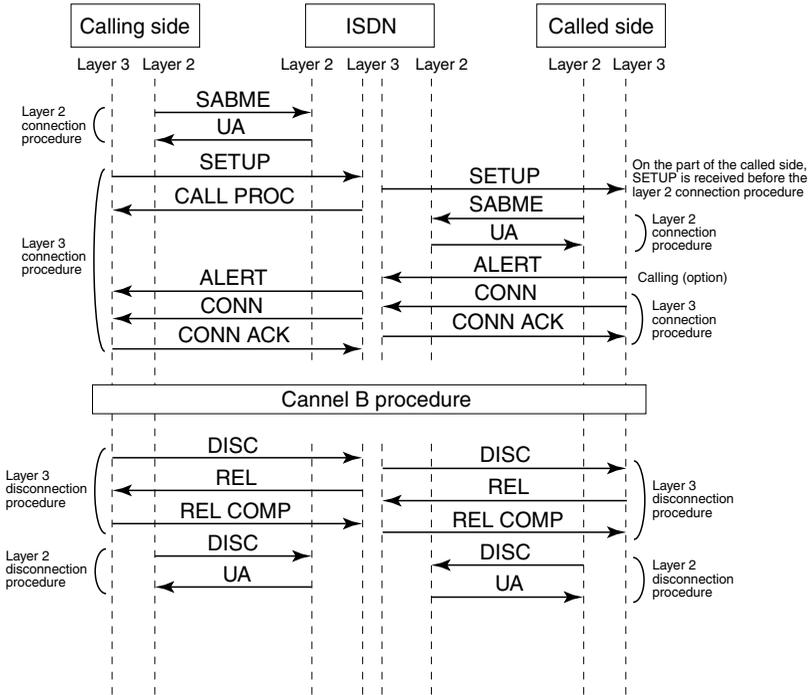
Figure 6 Channel D Control Procedure

A channel D procedure is basically a procedure between an exchange (ISDN network) and a terminal (facsimile machine), not requiring synchronization between signals between the terminal of the machine and that of the other party. Study the following for a channel D control procedure in circuit switching mode:

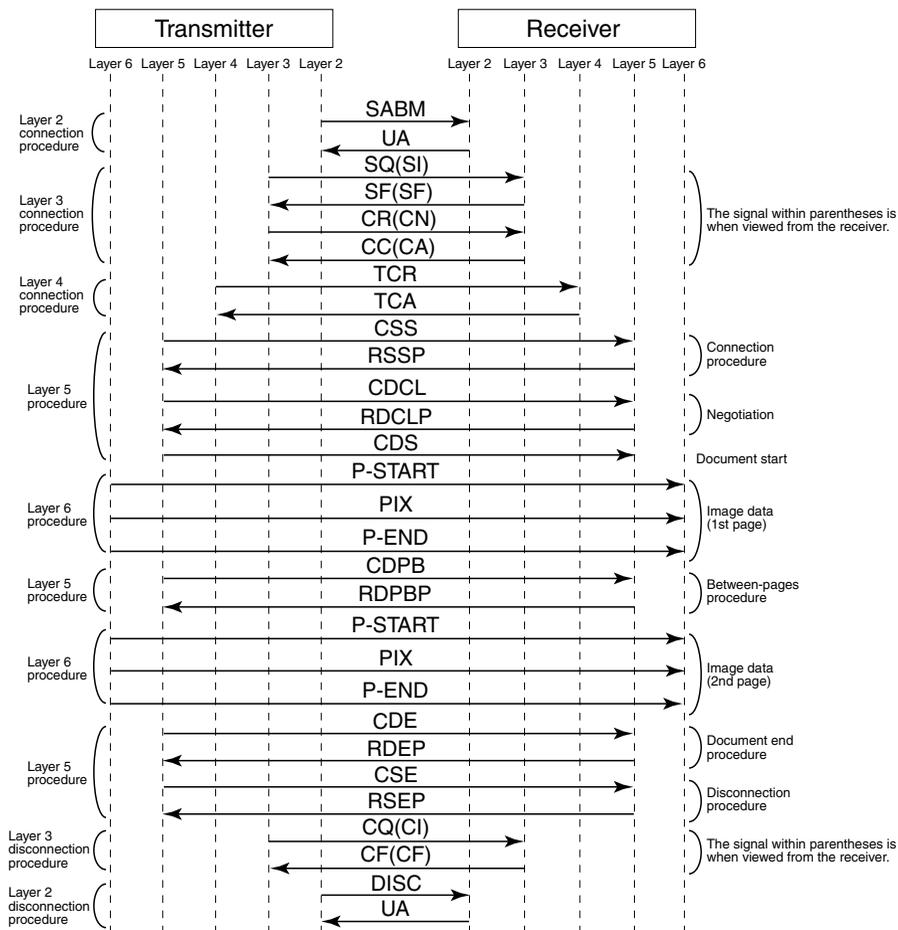
Figure 7 Channel B Control Procedure

A channel B procedure is executed while directly synchronizing the terminal of the machine and the terminal of the other party. Study the following for a channel B control procedure in circuit switching mode:
